TECHNICAL REPORT RL-76-13

2.75-INCH ROCKET LAUNCHER ICE PROTECTION  
TESTS, DECEMBER 1975 TO FEBRUARY 1976

Donald Davis  
Ground Equipment and Materials Directorate  
US Army Missile Research, Development and Engineering Laboratory  
US Army Missile Command  
Redstone Arsenal, Alabama 35809

18 March 1976

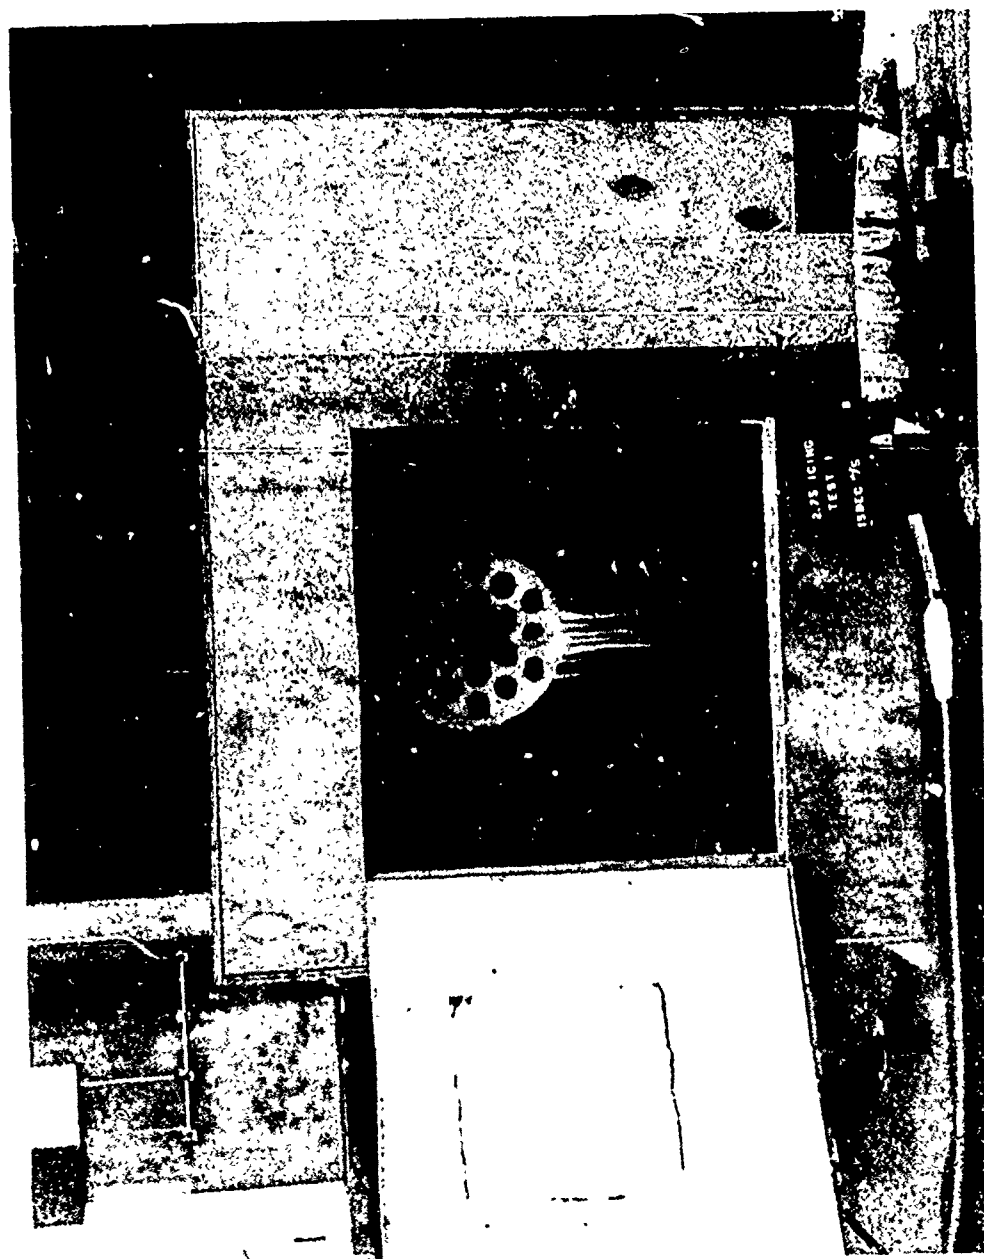
It was not known if ice could actually hold a rocket in a launch tube after the rocket is ignited. To test this, a single rocket was loaded into the center tube (tube No. 1). After the initial cooling, water was sprayed onto the launcher. On the first attempt, ice would not accumulate to the desired 1/2 inch, therefore, the firing test was postponed. Even with less than 1/2 inch of ice accumulation, the unfired rocket was firmly held in the tube. Removing the rocket, for safety, was difficult.

The test demonstrated that ice can hold a rocket in a launcher. At the very least, the launcher will be damaged severely. Calculations show that, under certain conditions, a helicopter will be impossible to control if a rocket is held after ignition. Multiple hangfires would compound this situation. Discussions with Cobra pilots confirm this conclusion.

Figure 2. Ice on unprotected launcher.

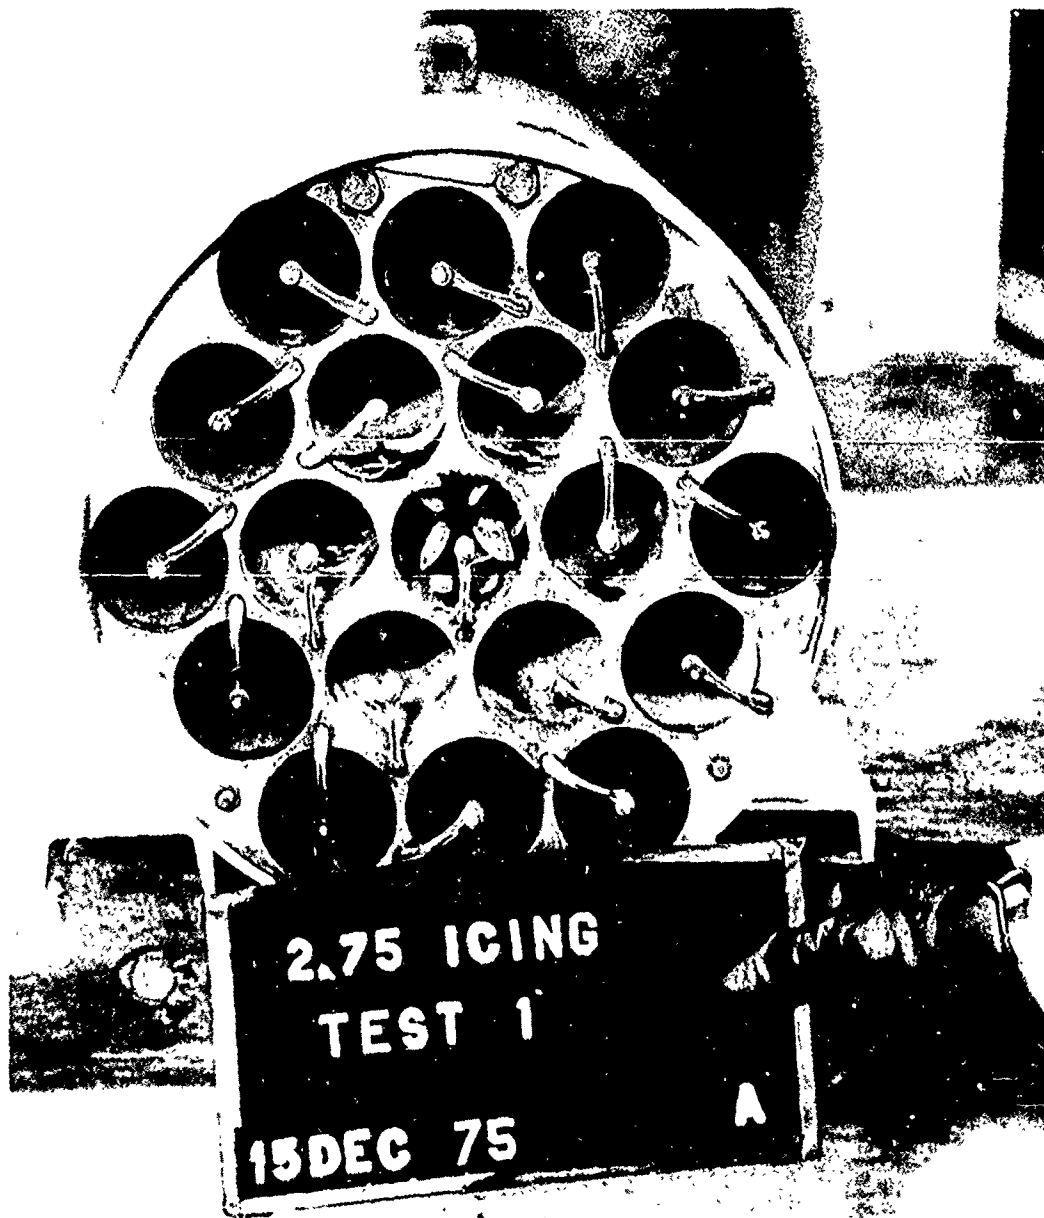
When the test was rescheduled, the range personnel insisted on placing tape around the rocket just forward of the fin and nozzle assembly. This was to prevent ice from building up around the fins. It was feared that if the rocket left the launcher, the fins might be frozen shut, thus causing a dangerously erratic flight. One-half inch of ice was built up on the upper face of the M200 launcher, but the ice thinned out around the center tube (Figure 2). However, the rocket was held in the tube when fired. The launcher was damaged severely and several tubes were rendered useless (Figure 3). Later examination showed that the rocket had moved forward approximately 1/2 inch, i.e., enough to clear the detent.

Figure 3. Aft end of unprotected launcher after firing.

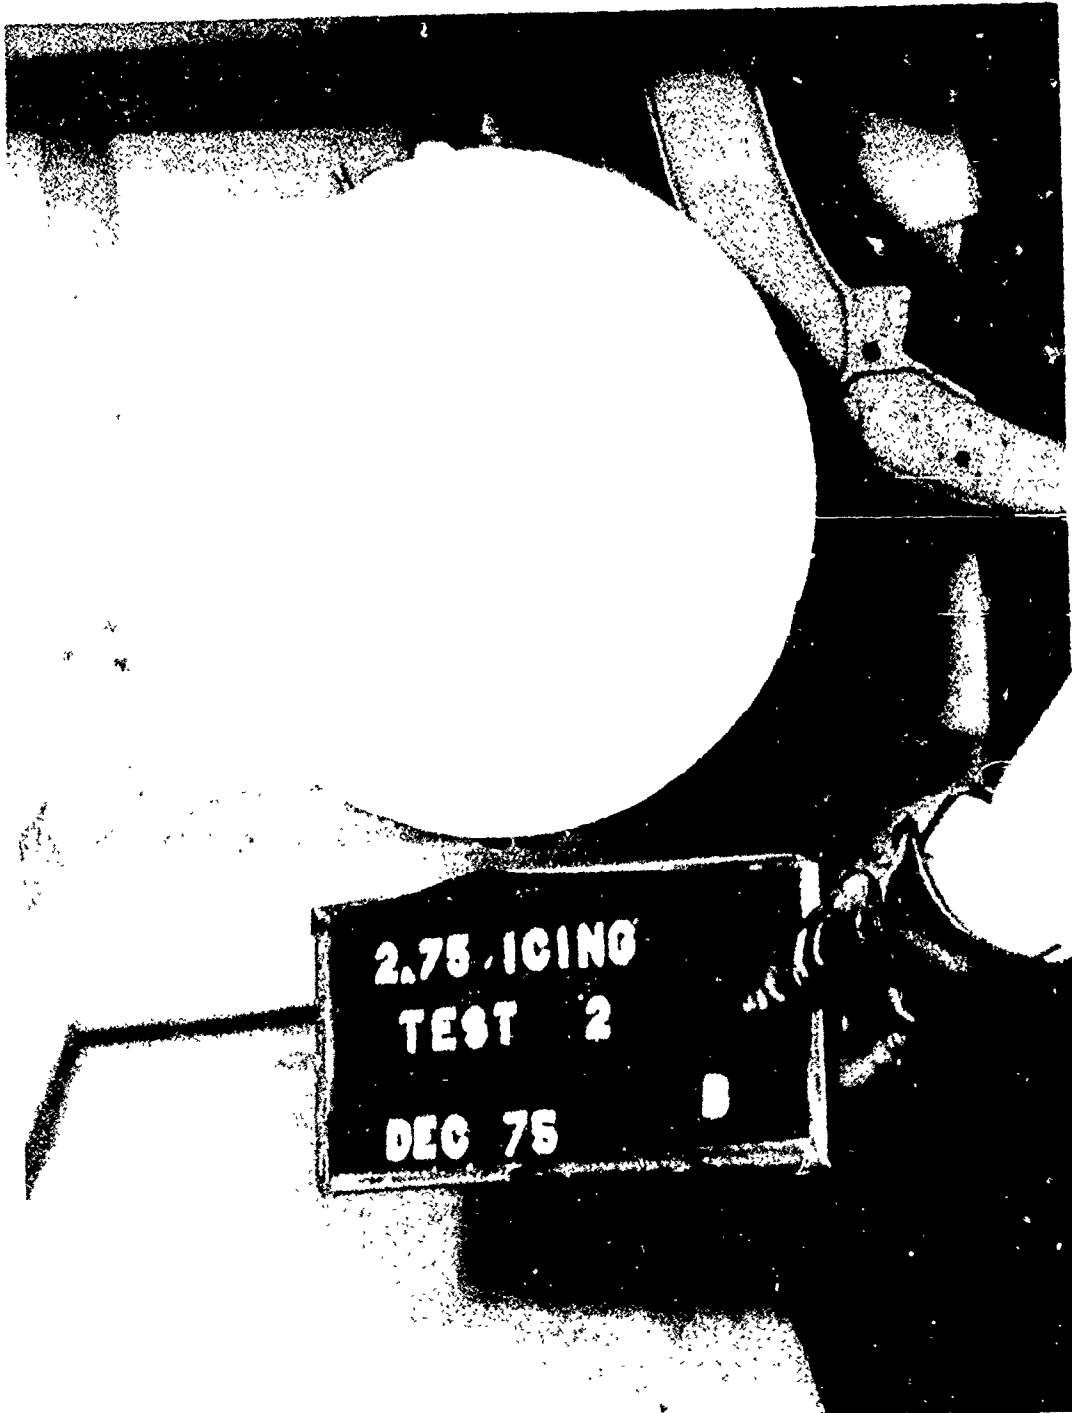
The 2.75-inch rocket Project Managers Office provided the Ground Equipment and Materials Directorate with several launcher dust covers from a previous effort. These were made of beaded styrofoam. They consisted of a 1/2-inch thick face and a 1-1/2-inch thick spacer. The spacer had a hole pattern similar to the hole pattern of a 19-round launcher. The cover fit very tightly inside the lip of the M200 bulk-head. To insure that it was secured in place, 2-inch mistick tape was used (Figure 4).

Figure 4. Dust cover installed.

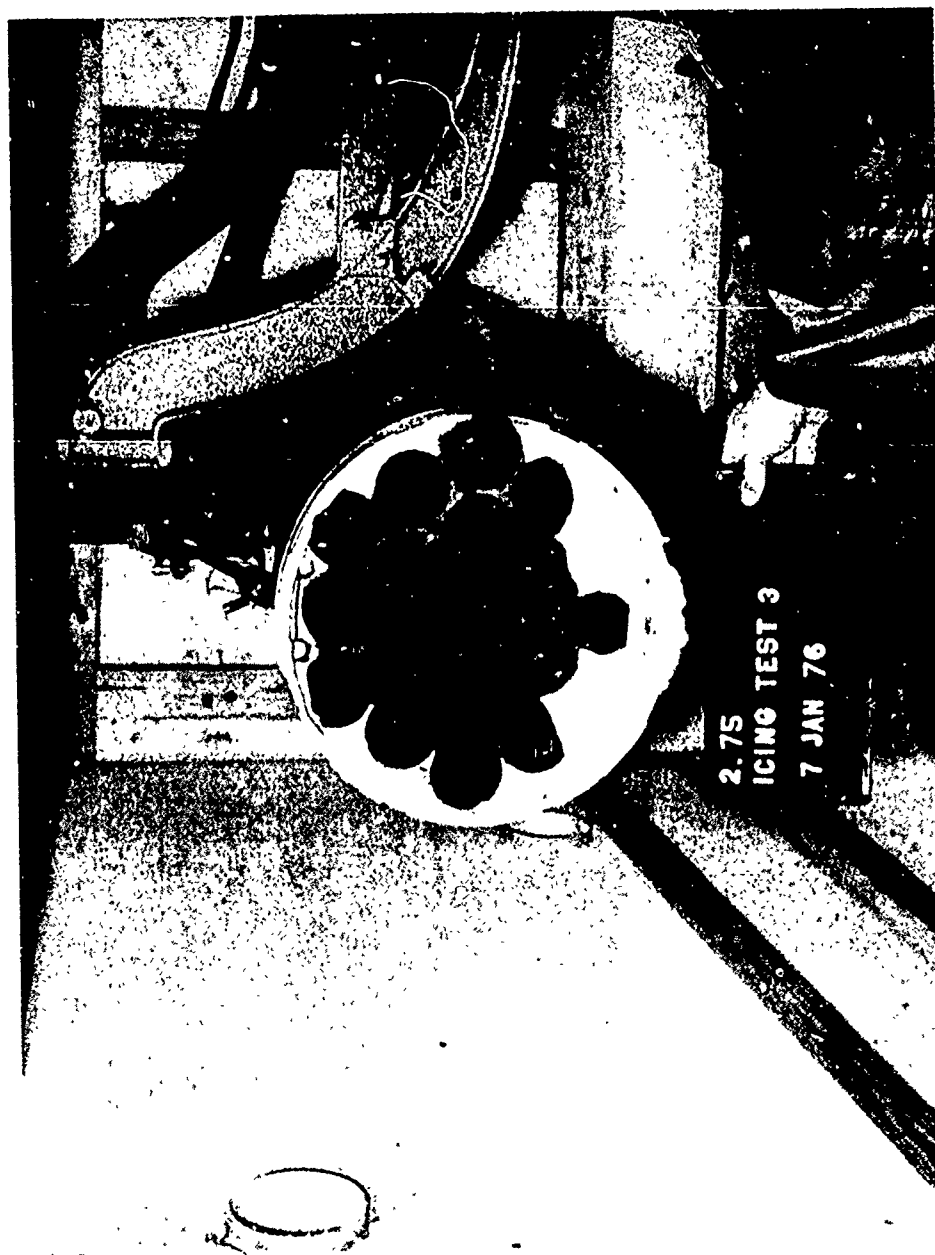
There was one unforeseen result. The plugs covering empty tubes were pushed through the length of the launcher and out the back end (Figure 8). The firing arm tore through the plugs as they left the aft end of the launcher.

Figure 8. Launcher after plug test firing, with ice.

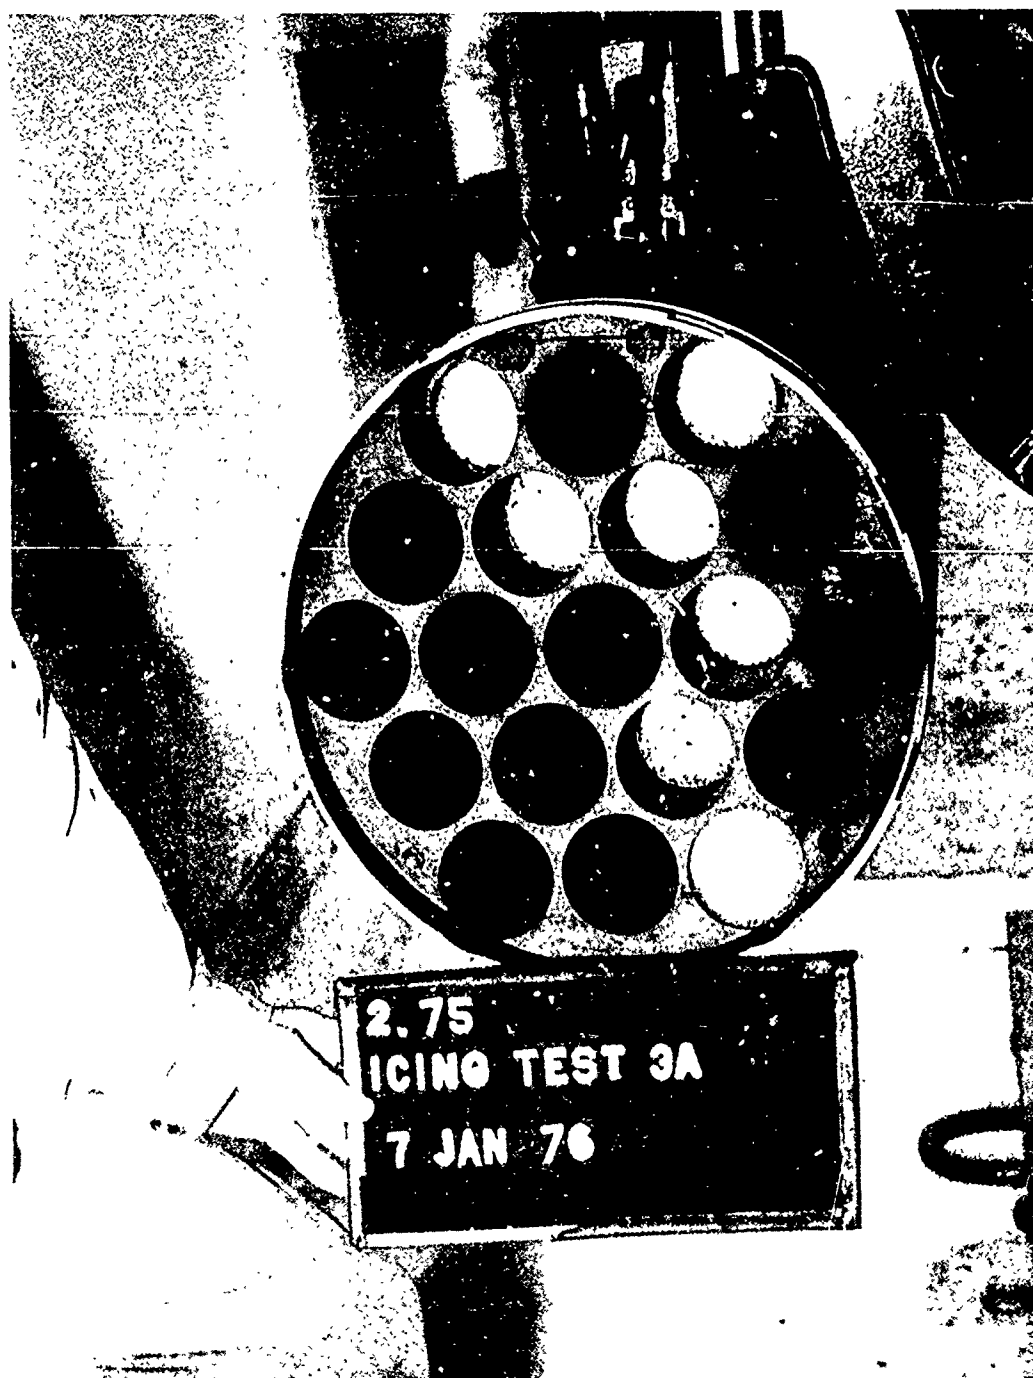
At firing, the plugs from the loaded tubes were shoved out ahead of the rockets. The plugs in the tubes loaded with inert rockets were shoved back until stopped by the fuze of the warhead (Figure 9). With the plugs now recessed in the tube, later icing could build up in front of the plugs. Although this condition was not tested, it is suspected that the launcher would be damaged if rockets were fired from this condition.

Figure 9. Launcher with plugs after firing, without ice.

Several methods to prevent the plugs from being pushed back were discussed, but never tested. Some of these methods were:

- 1) A shoulder made of a hard material, larger than the tube inside diameter.
- 2) A taper on the plug.
- 3) Increase the length of the plug so that it is resting against the warhead.

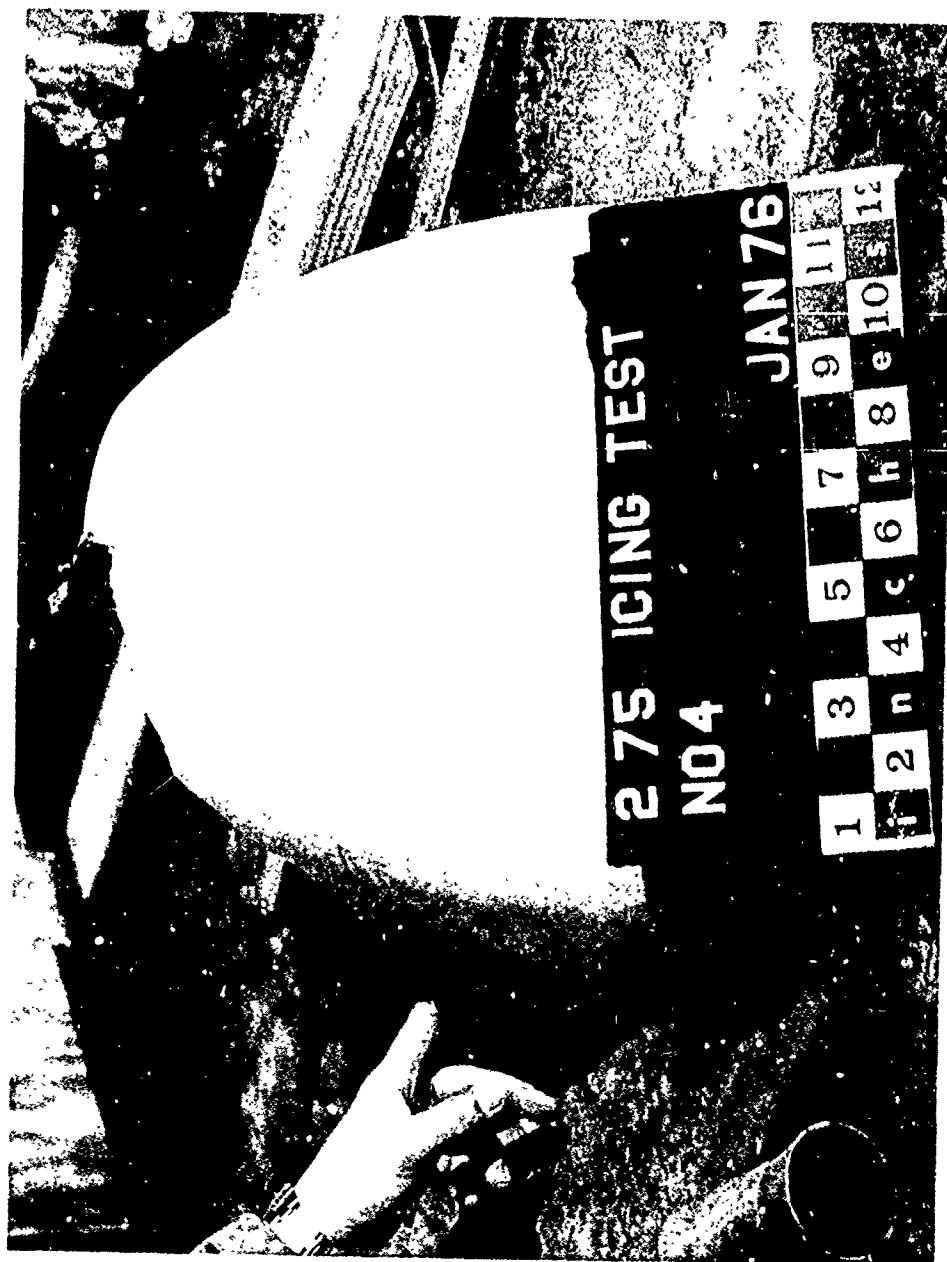
The fairing presents two problems. As with the dust cover, the protection is removed with the early rockets from the pod, thus leaving the launcher vulnerable to later icing. The fairing itself produces large pieces of debris. Discussions with pilots indicate that the size of the fragments is unacceptable (Figure 13).

Figure 13. Fairing fragment.

One possible direction of development would be to design a fairing that would break up in a satisfactory manner. An ice shedding or ice-phobic coating would be applied to the outside. To provide supplementary protection, plugs would also be installed.

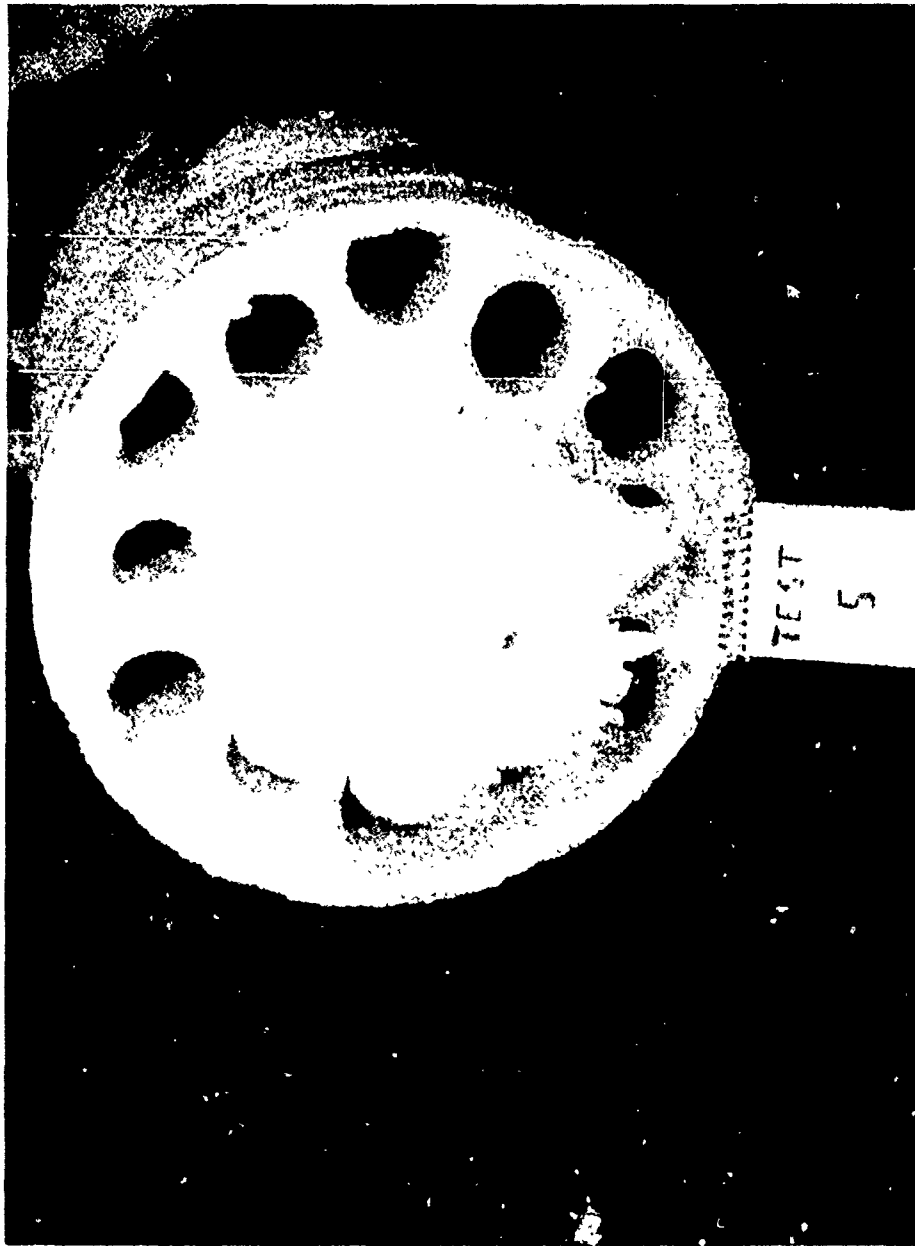
One live round was loaded into the center tube for the test. Six inert rockets with inert M229 heads were placed in tubes surrounding the live rocket. Ice was applied in the usual manner. By the time 1/2 inch of ice was built up, the seven protruding warheads had "grown" together (Figure 15). Ice fragments tended to be large and possibly dangerous to the aircraft (Figure 16).

Figure 15. Ring plugs, 17-pound warhead, 1/2 inch of ice.

that the trajectory was influenced by the ice. Future launchers should be designed to completely enclose the longest rocket/warhead combination. This will preclude the preceding problems.

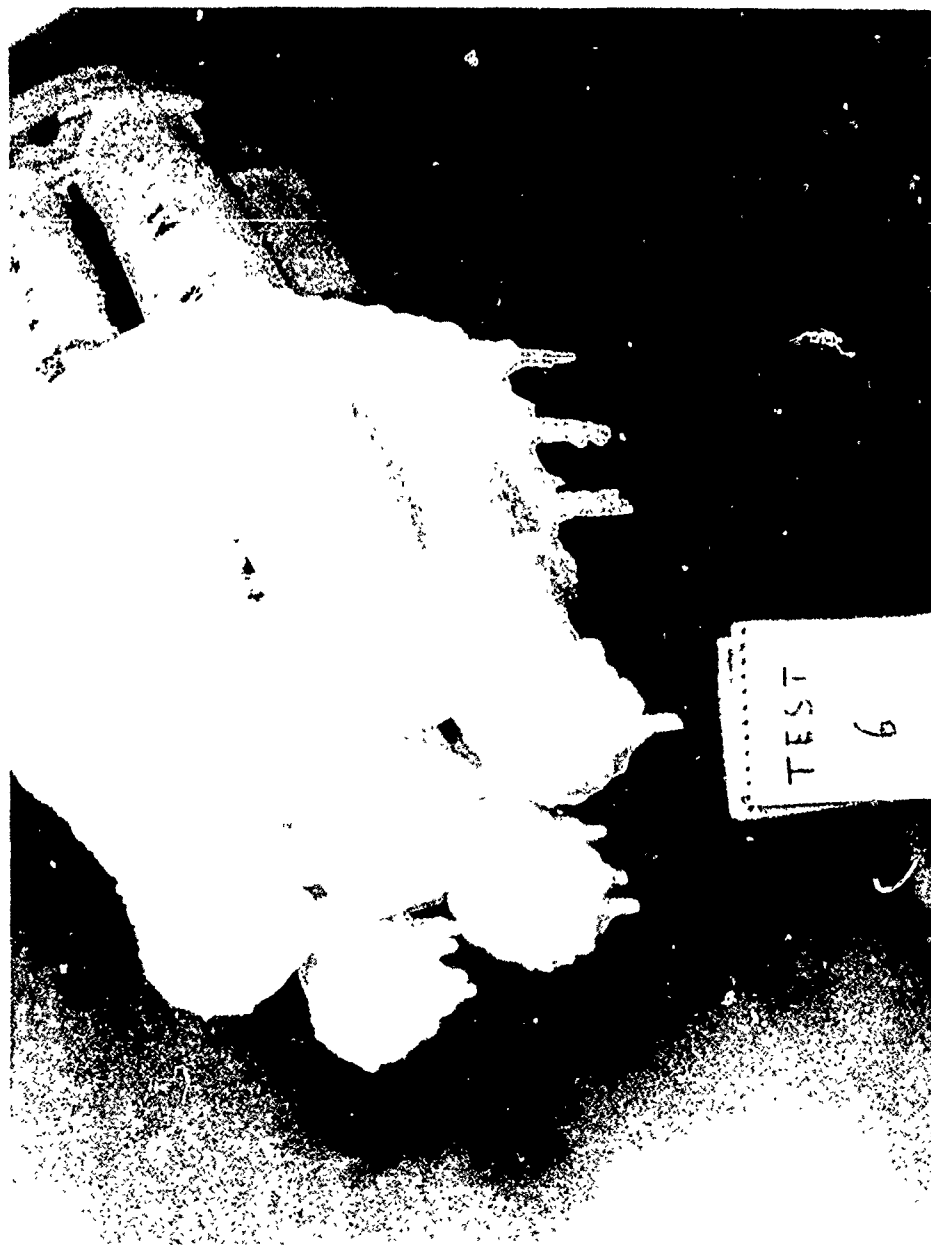
Tube No. 1 was loaded with a live rocket and a M229 warhead. Tube No. 2 is an outside tube. The other six tubes were loaded with inert rockets and warheads (Figure 17) and more than 1/2 inch of ice was applied (Figure 18). There was no evidence of runback inside the tubes.

The firing did not produce a large amount of debris. Data films show that a large amount of ice remained on the rocket at least during the first 20 feet of flight.

Since the illumination round does not require an accurate trajectory, it could probably tolerate the ice accretion. Other warheads requiring more accurate flight could not tolerate the ice coating.

Figure 18. Long warhead simulation, 1/2 inch of ice.

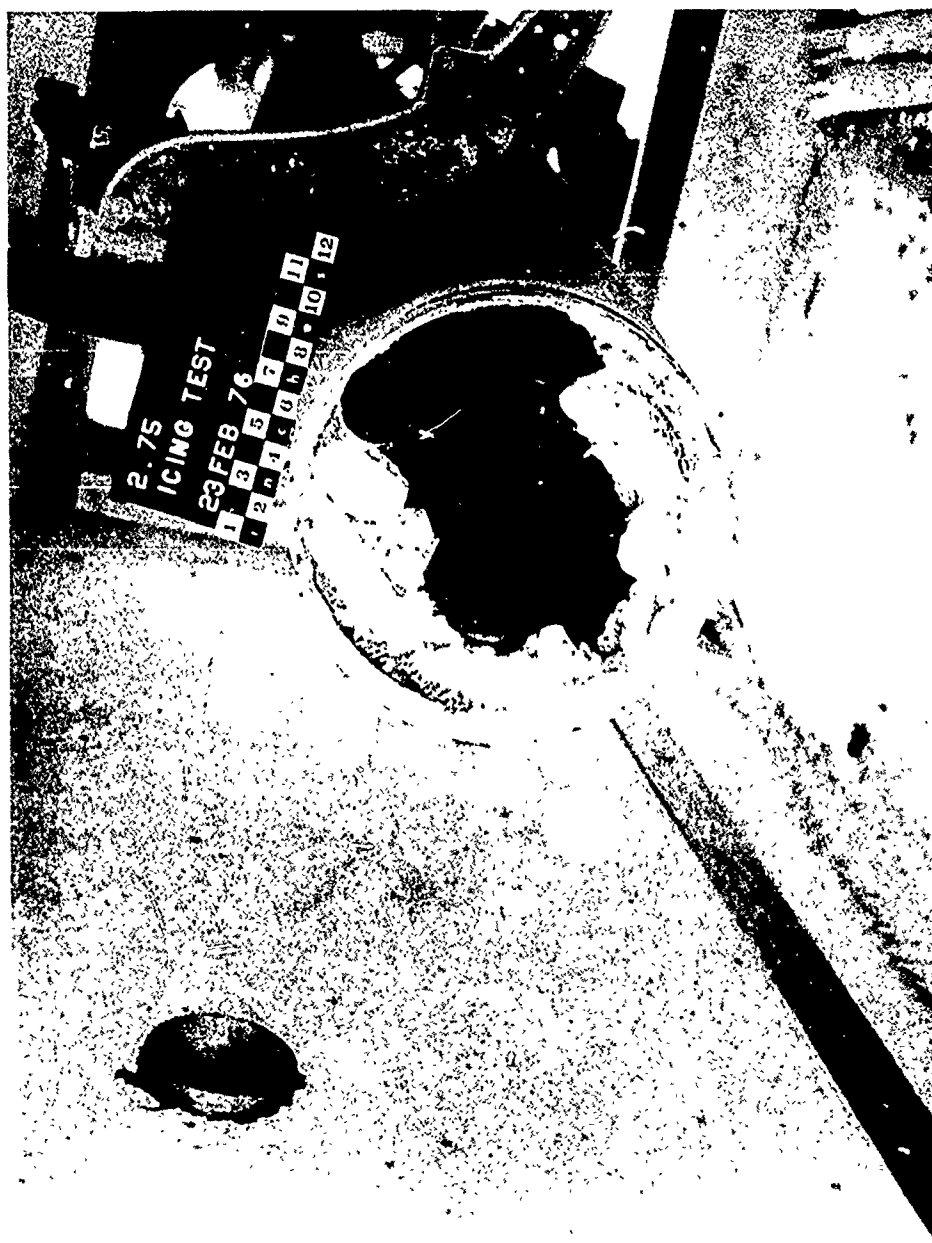
Debris was similar to that observed for the plug firing. The styrofoam was broken out of some of the tubes that were not fired. Data films show that the rocket backblast broke out the backing (Figure 21).

Figure 21. Heater bulkhead, after firing.

The test demonstrated an approach that would allow rapid installation. However, a stronger foam is required, perhaps polyurethane. This general approach could be used as an alternative to plugs or used with a heater.
